Manhole Inspection Summary

Manhole # S29GG2021MH

Location Address: **6100 N CHARLES ST**

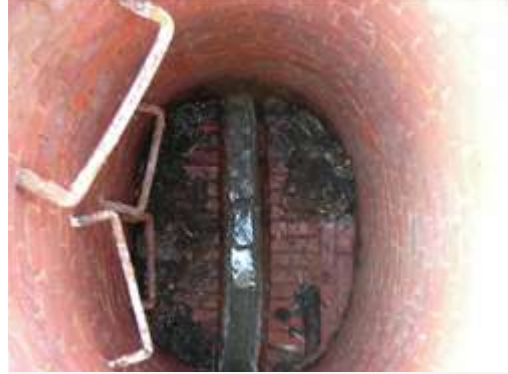
Top View

Adjustment infiltration. Corroded steps.
Evidence of surcharge - Bench debris.

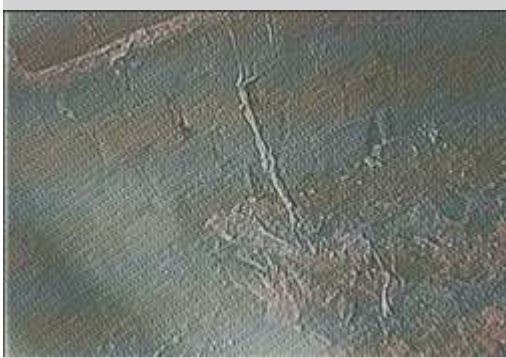
Defect

Barrel deterioration and infiltration.

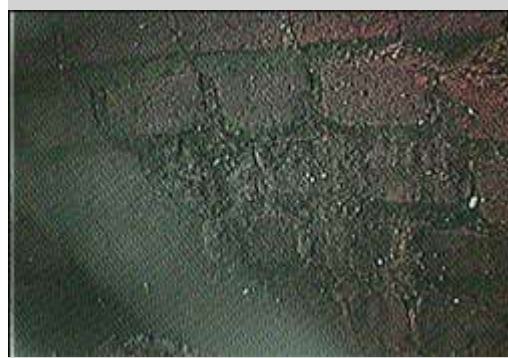
Defect

Barrel infiltration.

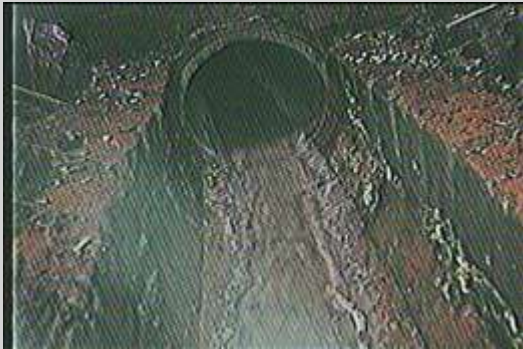
8 in. Circular Gravity Sewer Pipe Out @ 12 O'Clock

Infiltration: **Evidence** Pipe Seal Cond: **Unknown**

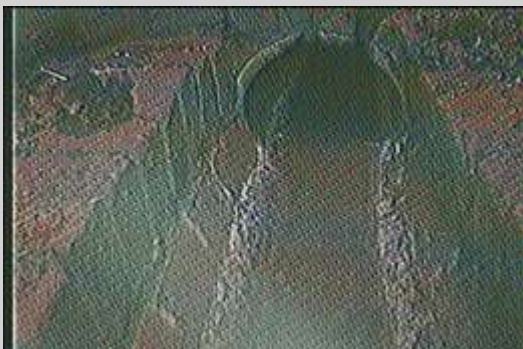
8 in. Circular Gravity Sewer Pipe In @ 6 O'Clock

Deposits: ☐ None ☐ Mud ☐ Sludge ☐ Debris ☒ Grease

Silt Depth: **0** (in.) Deposits Extent: **Light**

Infiltration: **Evidence** Pipe Seal Cond: **Broken**
